Quality Assurance and Source Inspection

Contract #: 04-0120F4Cty: SF/ALA Rte: 80 PM: 13.2/13.9File #: 69.28**WELDING INSPECTION REPORT****Resident Engineer:** Pursell, Gary**Address:** 333 Burma Road**City:** Oakland, CA 94607**Report No:** WIR-014275**Date Inspected:** 02-May-2010**Project Name:** SAS Superstructure**OSM Arrival Time:** 700**Prime Contractor:** American Bridge/Fluor Enterprises, a JV**OSM Departure Time:** 1900**Contractor:** Zhenhua Port Machinery Company, Ltd (ZPMC), Changxing Island **Location:** Shanghai, China**CWI Name:** Wu Chi Cheng**CWI Present:** Yes No**Inspected CWI report:** Yes No N/A**Rod Oven in Use:** Yes No N/A**Electrode to specification:** Yes No N/A**Weld Procedures Followed:** Yes No N/A**Qualified Welders:** Yes No N/A**Verified Joint Fit-up:** Yes No N/A**Approved Drawings:** Yes No N/A**Approved WPS:** Yes No N/A**Delayed / Cancelled:** Yes No N/A**Bridge No:** 34-0006**Component:** Orthotropic Box Girder(OBG)**Summary of Items Observed:**

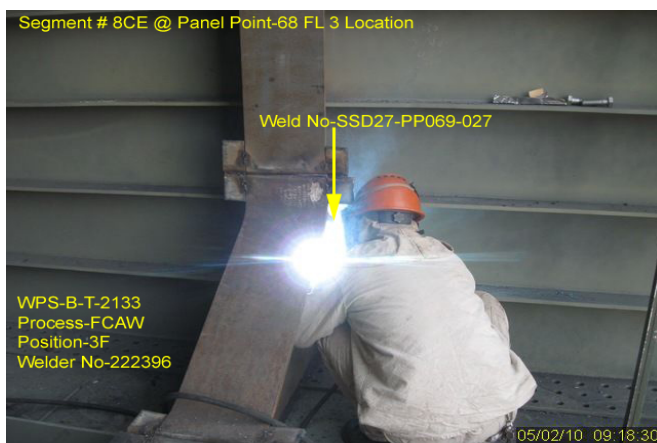
Segment # 8CE-PP68

This QA inspector observed ZPMC qualified welding personnel identified as 222396 perform Flux Core Arc Welding (FCAW), weld joint identified as SSD27-PP069-027; ZPMC QC is identified as Mr.Feng Ya Jun. The welding parameters measured using QC's calibrated instrument appeared to be in general compliance with WPS-B-T-2133. See the attached below Photo.

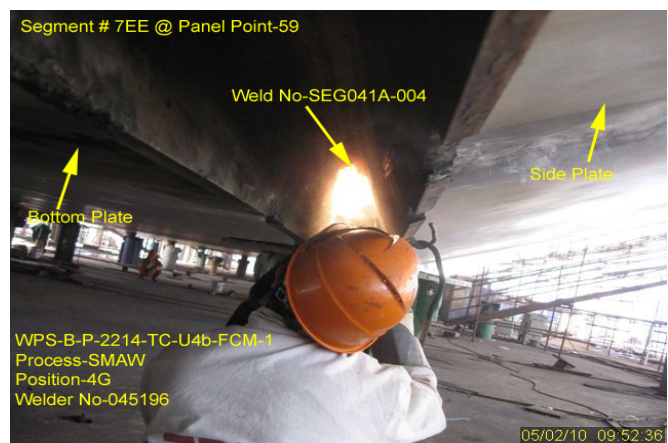
Segment # 7EE-PP59

This QA inspector observed ZPMC qualified welding personnel identified as 045196 perform Shielded Metal Arc Welding (SMAW), weld joint identified as SEG041A-004; ZPMC QC is identified as Mr.Feng Ya Jun. The welding parameters measured using QC's calibrated instrument appeared to be in general compliance with WPS-B-P-2214-TC-U4b-FCM-1. See the attached below Photo.
